**COUNTY OF SCHENECTADY  
BID#: RFB-2018-25  
NEW BUILDING:  
SCHENECTADY COUNTY LIBRARY-  
MONT PLEASANT BRANCH**

**DOCUMENT 009000 - ADDENDUM #2 – 2/14/18:**

**REPORT OF  
PRE-DEMOLITION HAZARDOUS  
MATERIALS SURVEY REPORT**

Re: Pre-Demolition Hazardous Materials Survey Report  
1026 Crane Street  
Schenectady, New York, 12305  
PSI Project No. 08212746

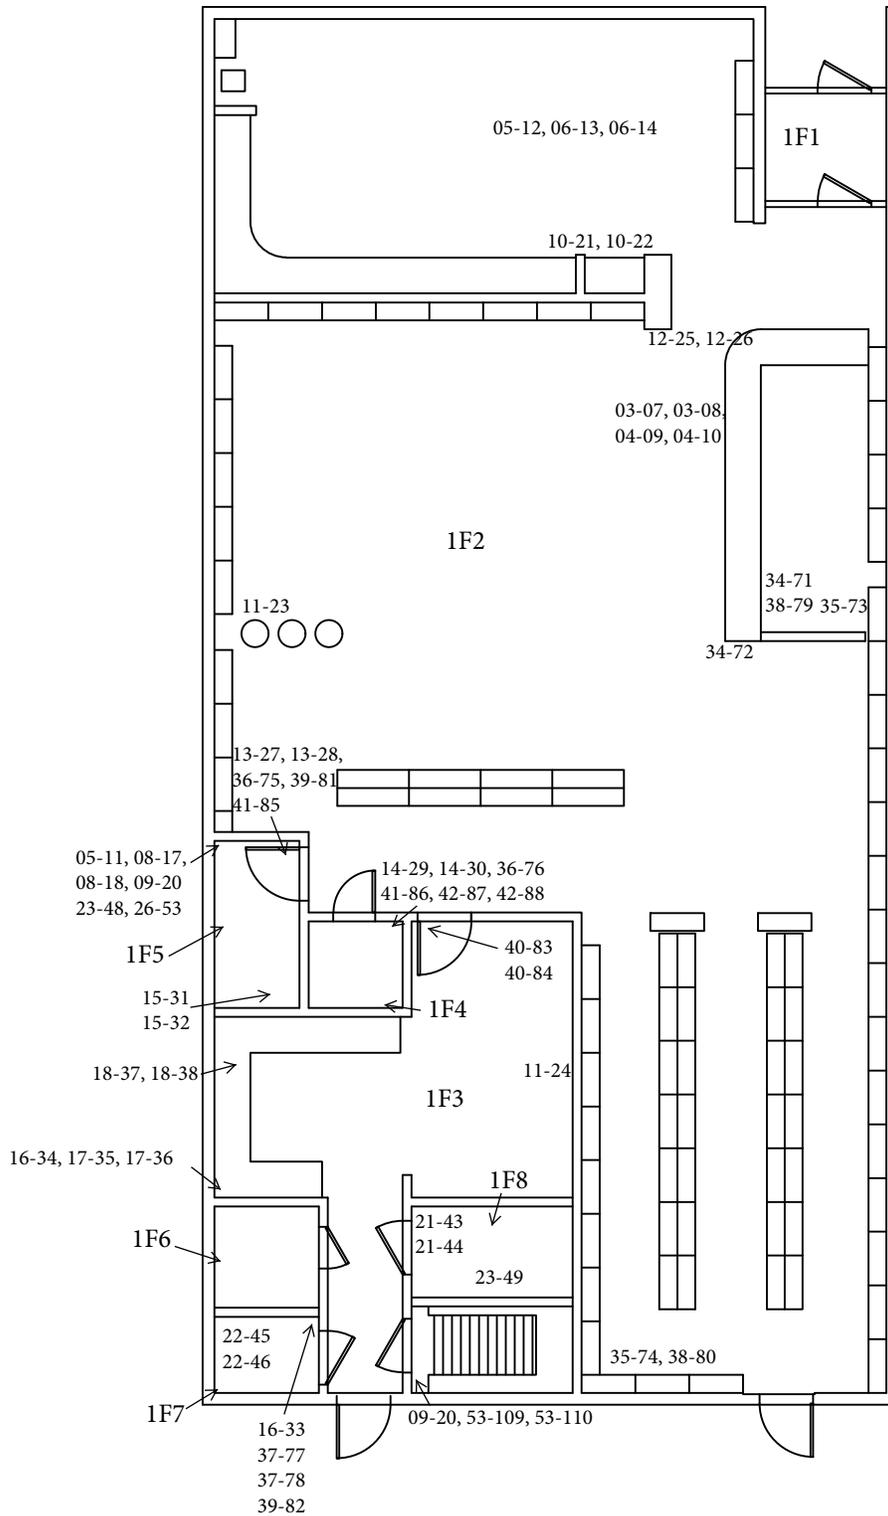
# Mont Pleasant Branch Library Floor Plan

**APPENDIX D – SITE LAYOUT AND SAMPLE LOCATION DRAWING(S)**

The main floor of the building is divided between an open floor library and faculty rooms which include a breakroom, restrooms, and access areas to both attic and basement. A drop ceiling was present through-out the main floor. PSI's inspector observed a tin ceiling nailed into wooded decking above the drop ceiling which had a black vapor barrier located beneath the tin ceiling. PSI checked the interior perimeter of the building above the drop ceiling and observed that the framework consisted of bricks with large sections of brick mortar located across the bricks. The main floor was carpeted and was placed over wood. The back areas of the building had carpeted flooring with 12" x 12" tan floor tile located beneath, with a purple floor tile beneath the tan. The size of the gray floor tile could not be determined. Both carpet and floor tile were adhered to wooden floor boards. It should be noted that the floor tile, associated mastics and carpet adhesives were sampled and all samples analyzed not to contain asbestos. A full list of suspect asbestos containing materials found on the main floor can be found in Appendices E.

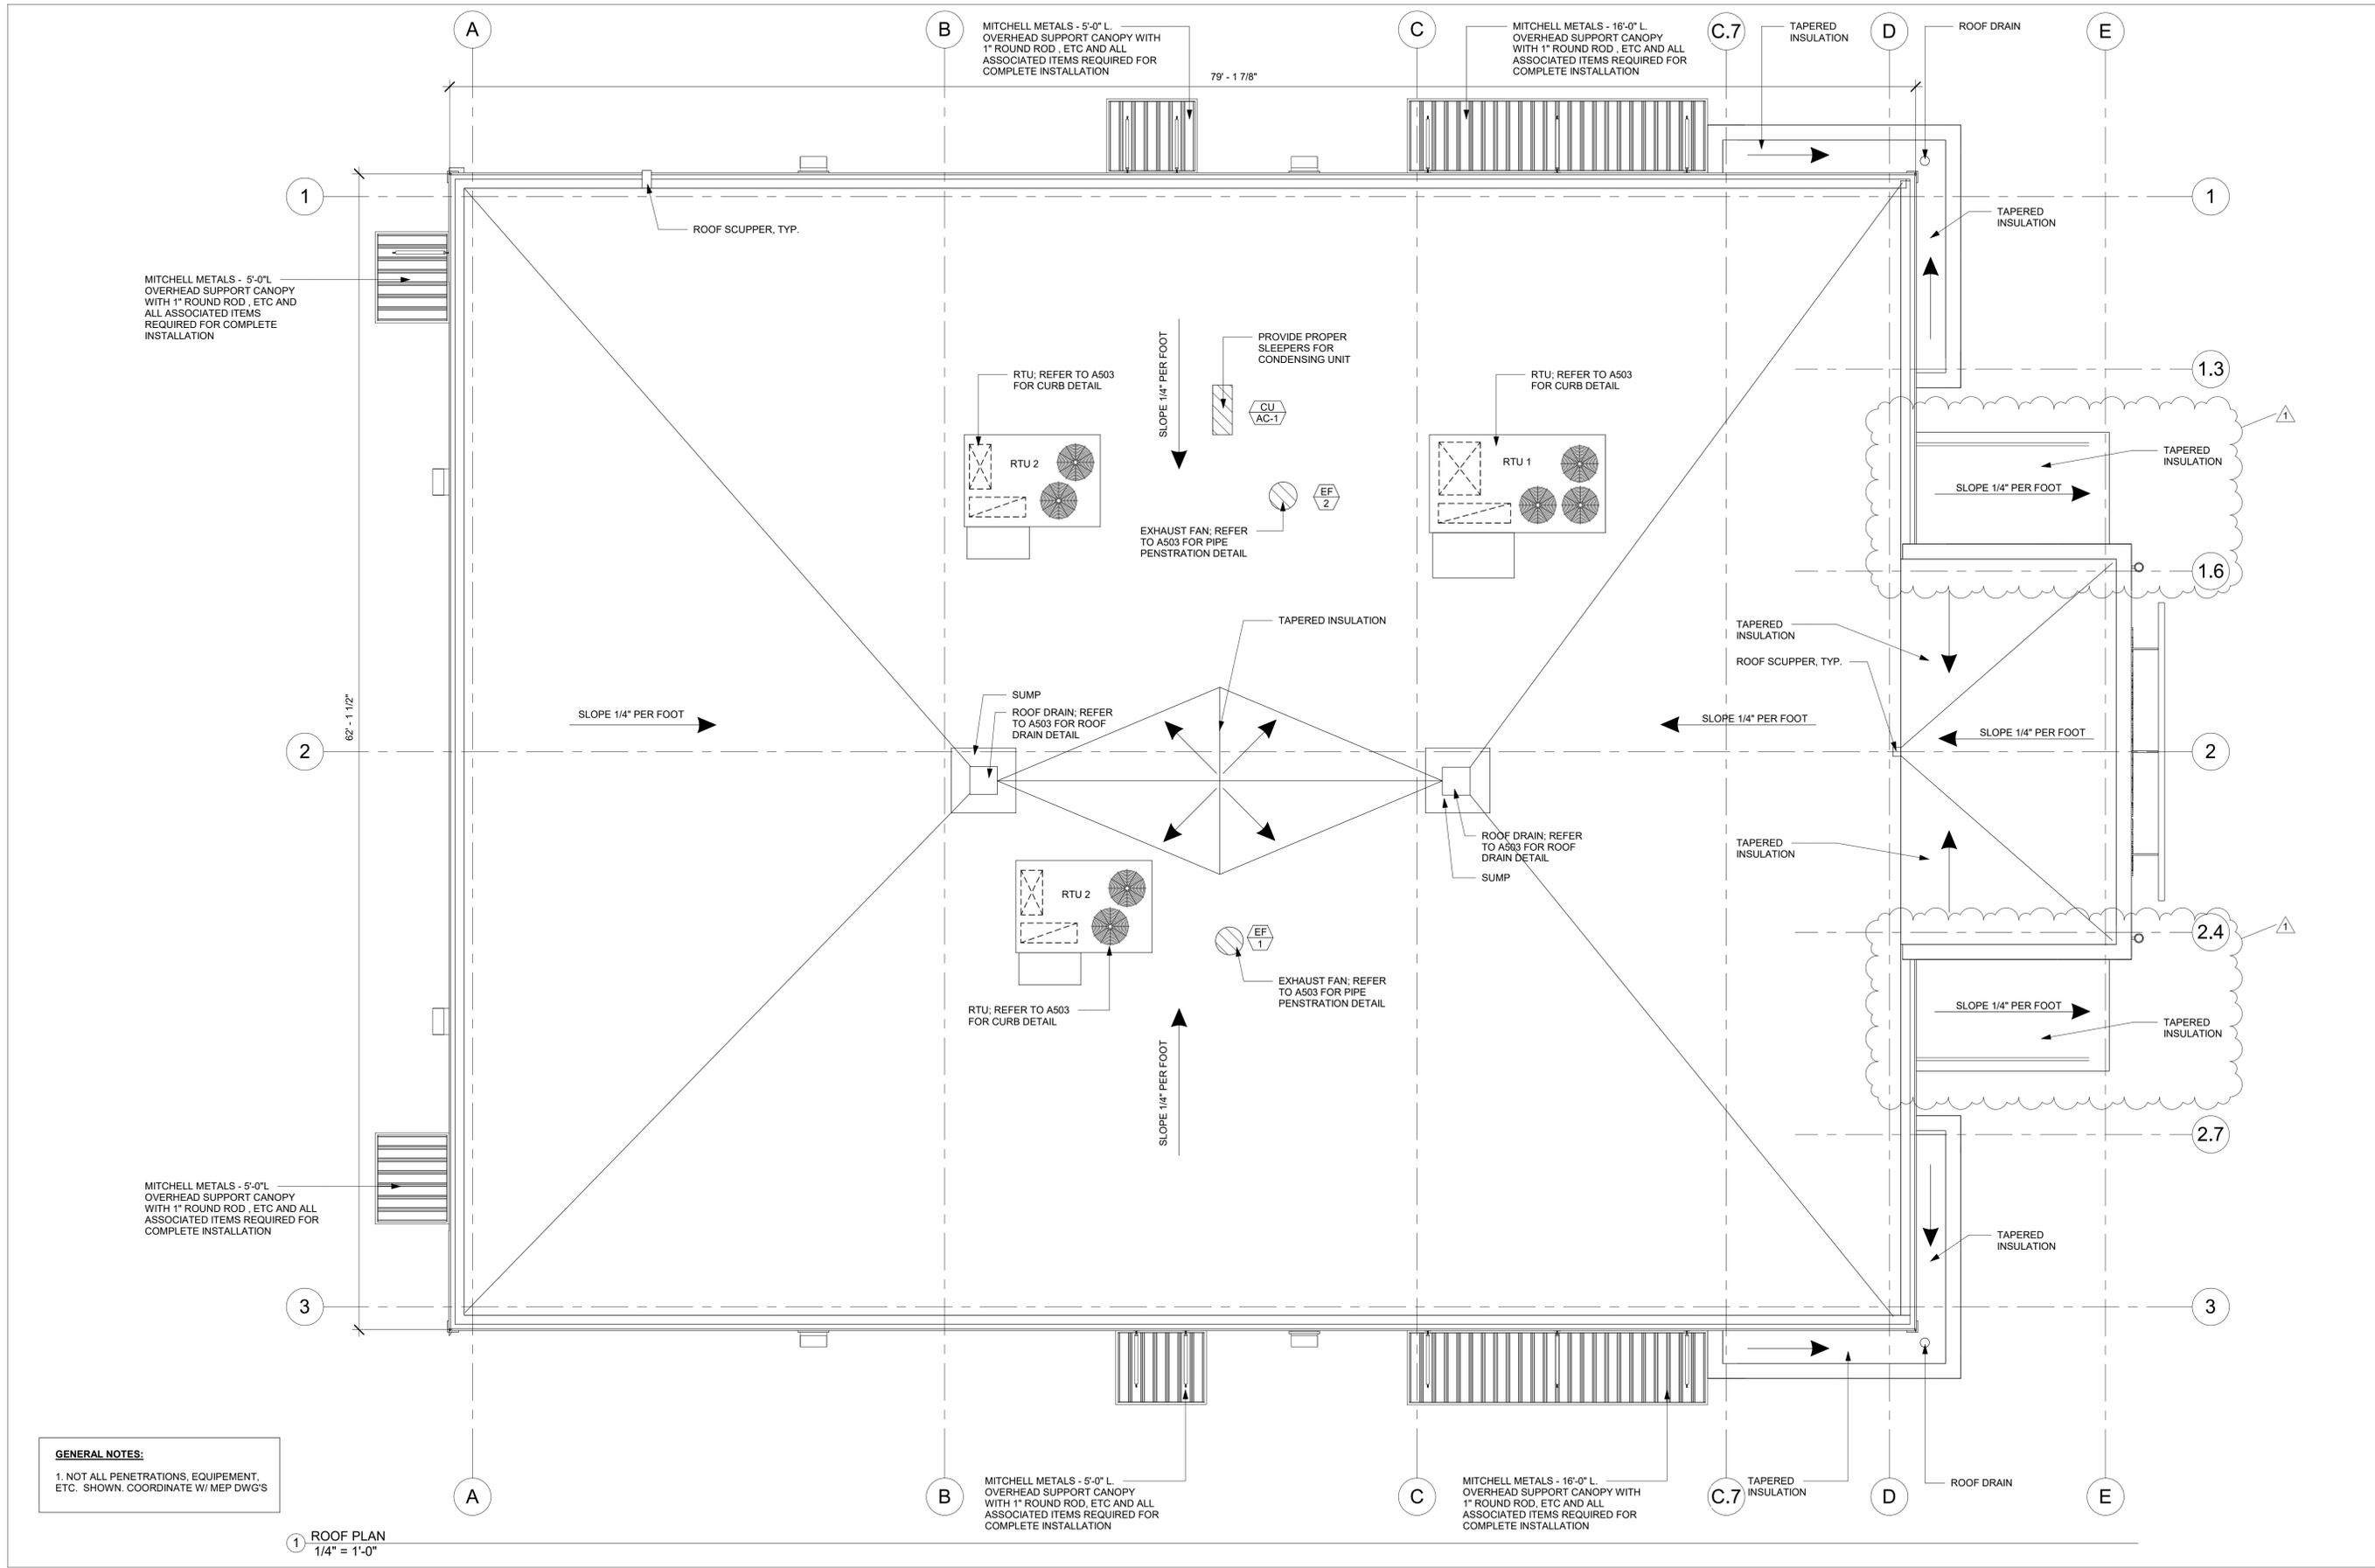
1 ROOF PLAN  
 1/4" = 1'-0"

**GENERAL NOTES:**  
 1. NOT ALL PENETRATIONS, EQUIPMENT, ETC. SHOWN. COORDINATE W/ MEP DWG'S

1. Replace existing drawing A110 with attached revised drawing A110 w/  
Revision #1 clouded.
